**CONNECTICUT RIVER BASIN
OLD LYME, CONNECTICUT**

**ROGERS LAKE DAM
CT. 00418**

**PHASE 1 INSPECTION REPORT
NATIONAL DAM INSPECTION PROGRAM**

**DEPARTMENT OF THE ARMY
NEW ENGLAND DIVISION, CORPS OF ENGINEERS
WALTHAM, MASS.
SEPTEMBER, 1980**

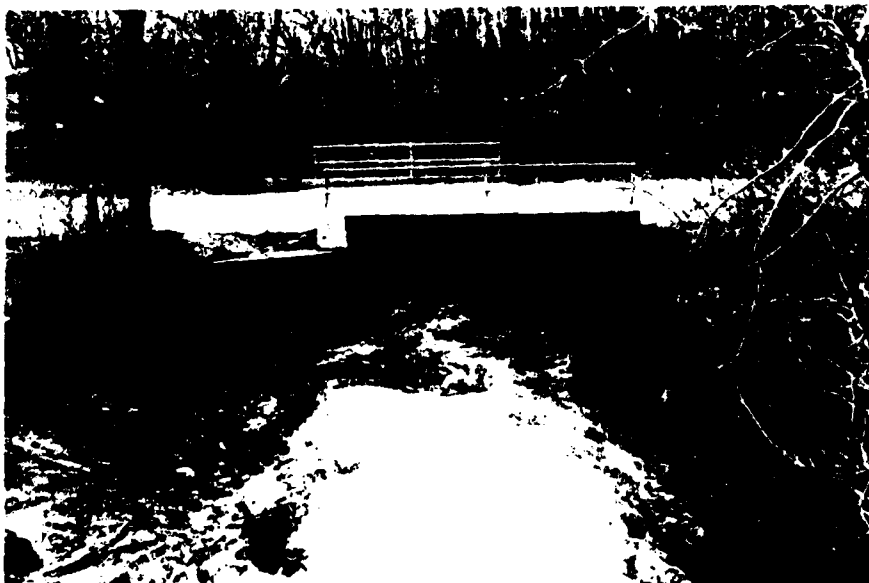
PHOTO C-10 Spillway and outlet works discharge channel.

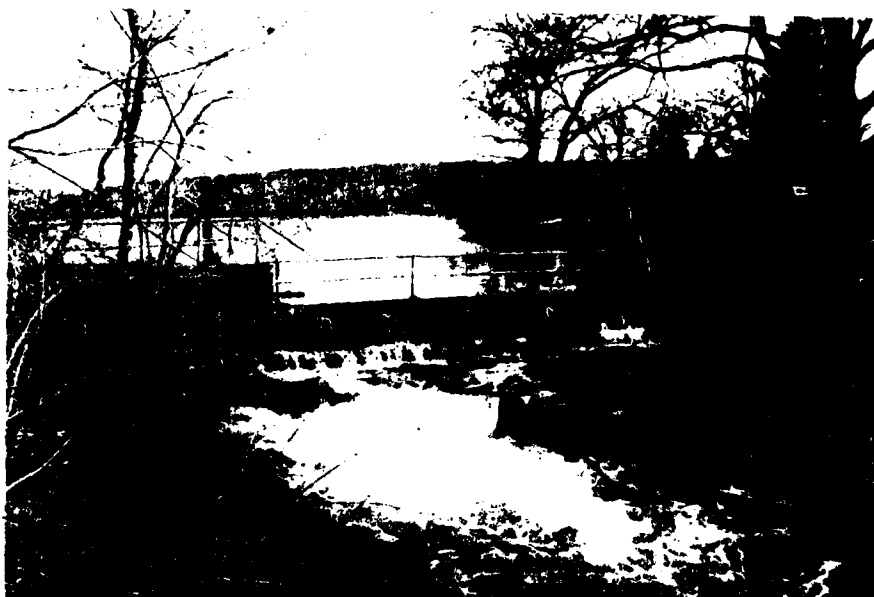
The downstream face consists of a 12-inch-wide concrete wall on each side of the spillway, (Photos C-5 and C-7). To the right of the spillway the concrete wall is about 18 feet long and has spalled and cracked in several locations. Seepage was observed through a spalled area at the base of the wall located about 6 feet from the left end of the wall and about 5.5 feet below the top of the wall (Photo C-11). The spalled area has dimensions of about 15 inches by 6 inches, and a wooden rule could be placed 8 inches into the spalled area. The seepage appeared to be clear and was flowing at a rate of about 3 gallons per minute. The area downstream of the right wall is covered with thick brush and trees. A 12-inch diameter tree is located about 7 feet from the right corner of the wall. To the left of the spillway the concrete wall is about 24 feet long with mortared stone blocks forming the right portion of the wall. A 26-inch diameter tree is located about 10 feet from the wall, and several small tree stumps are located close to the downstream toe of the wall. An extensive root system is located near the downstream toe of the wall and is apparently part of the large tree located 10 feet from the wall. A wet area with dimensions of about 25 feet by 10 feet is located just downstream of the large tree shown in Photo C-7 and is about 6 feet below the top of the dam. It could not be determined if the wet area is seepage through the dam. An area of lush green growth, about 7 feet by 7 feet, is located to the left of the downstream wall, (see Photo C-5). The cause of this growth is unknown.

PHOTO C-7 Spillway and embankments from downstream right side.

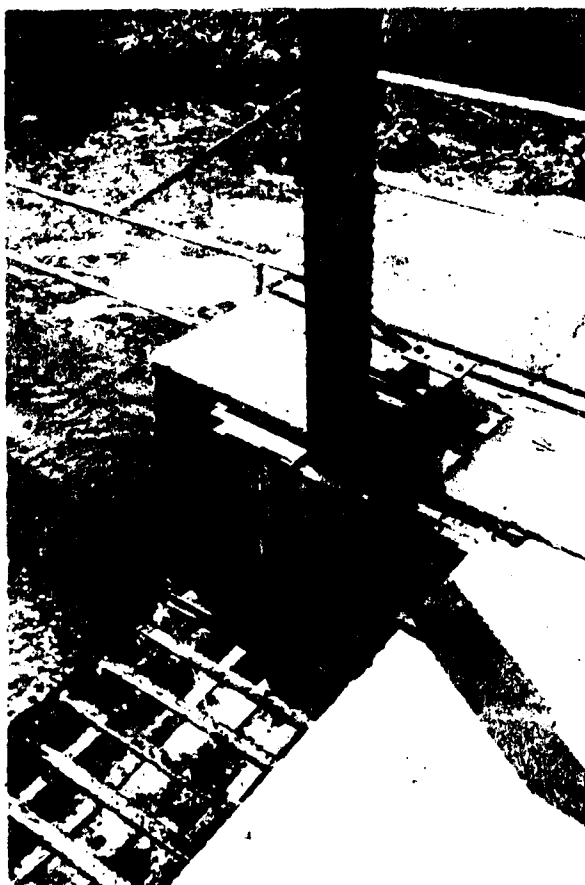
PHOTO C-8 Outlet works intake structure and gate control.

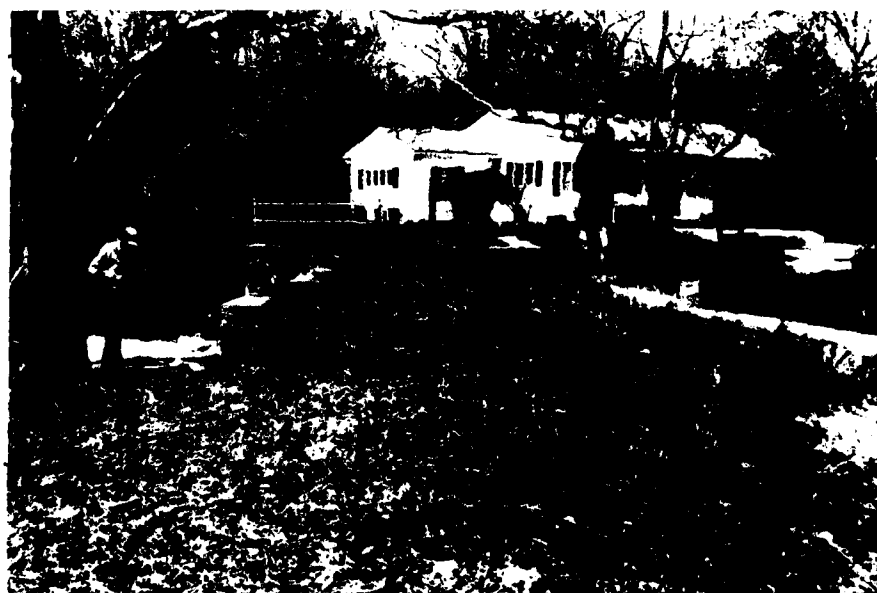
the spillway the width of the crest is about 9 feet (Photo C-4). The ground surface is irregular and is barren in places. Several tree stumps up to 6 inches in diameter were observed on the crest.

PHOTO C-4 Crest of embankment from left side.

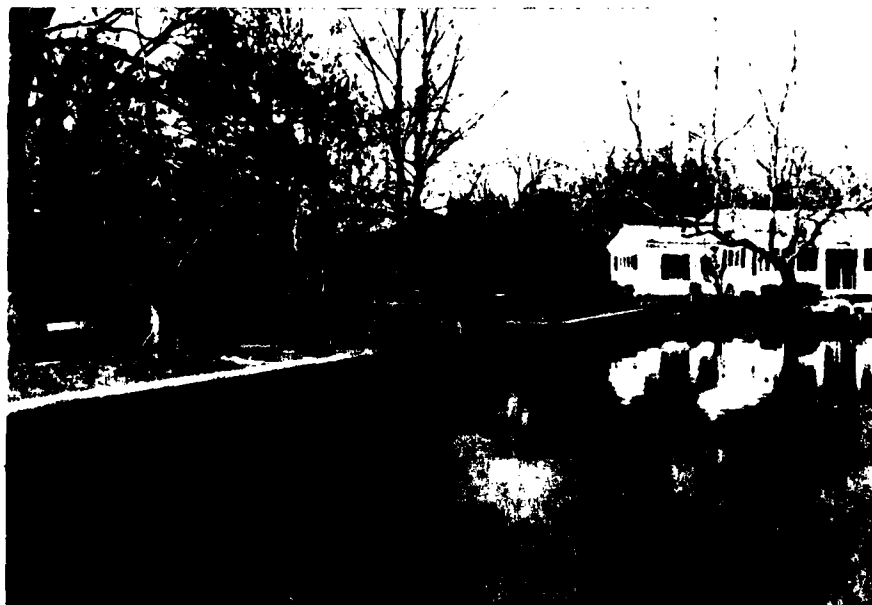
The upstream face of the dam consists of a 24-in.-wide concrete wall on each side of the spillway (Photos C-1, C-2 and C-3). The visible portion of the wall on the right side of the spillway is in generally good condition and shows no sign of misalignment. The grassy area to the right of the wall is at a lower elevation than the top of the wall, (Photo C-13). The low spot of this grassy area is about 17 feet from the right end of the wall and is about 0.5 feet lower than the top of the wall, (Photo C-5). The wall on the left side of the spillway consists of two sections: a 34-ft.-long, 24-in.-wide section and a 19-ft.-long, 10-in. -wide section. Spalling of both sections was observed and a 1/2 inch wide vertical crack with a 1/4 inch offset was observed near the center of the 10-in.-wide wall, (Photo C-12). The ground surface to the left of the wall is lower than the top of the wall. A 25-ft.-long row of sandbags, partially eroded, is located to the left of the wall (Photos C-13 and C-14). Sandbags were needed to prevent high stages in the lake from flowing around the left abutment of the dam at a low area.

PHOTO C-1 Upstream face of dam from left side.
